Building Survey Forms for Heterogeneous Urban Areas in Seismically Hazardous Zones. Application to the historical center of Valparaíso, Chile

Running head: Building survey for seismically hazardous urban areas

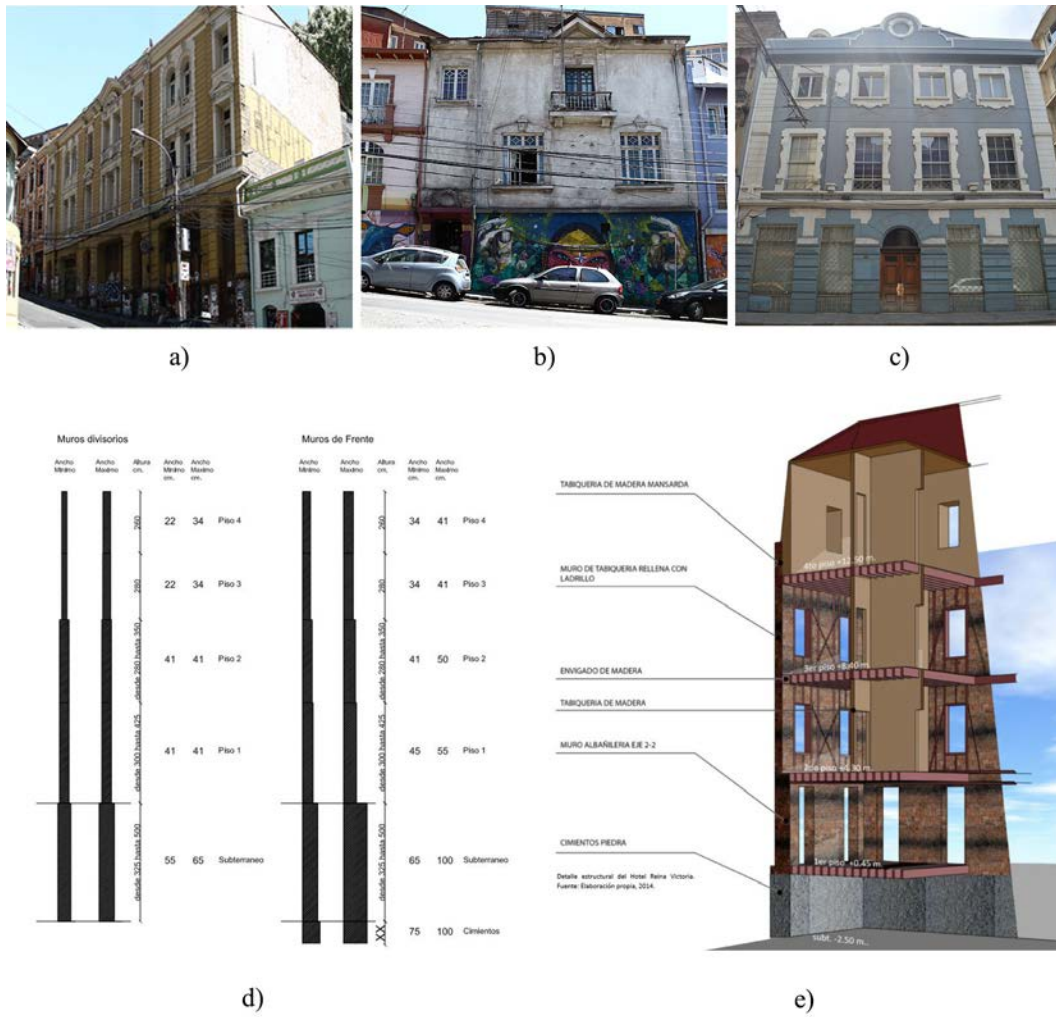
Masonry buildings are mostly medium-rise buildings having between 2 to 4 stories with an average height of 3.5 m each. Historical masonry constructions (see examples in Figure 11a-c), built without anti-seismic design regulations in the early 20th century, were carefully inspected. Roofs and stories, as well as internal configurations, presented the most challenging inspection conditions due to restricted access. For such cases, data extrapolation and some hypotheses based on the literature were considered.

With respect to the structural regularity, most of the masonry buildings presented regular shapes in plan and elevation and are enclosed in-row configurations. According to Formisano et al. (2011), the interaction of the buildings in aggregate affect meaningfully their seismic response. Buildings enclosed between lower constructions and placed at either the corner or the end of the aggregate were determined as the most vulnerable cases in this study. Most of the buildings of the study area have central positions in-row configuration and present similar heights in line, a condition which contributes to the good seismic behavior of the buildings. According to Siano et al. (2017), irregular openings in a wall, e.g. with different horizontal dimensions or variable number, negatively affect the load path within the structure and the global seismic response. Even though most of the studied masonry buildings present regularly distributed openings, some critical cases presented irregularities such as offsets or openings with different dimensions, as shown in Figure 11b.

Figure 11. Typical features of masonry buildings in Valparaíso: (a-b) façades in Almirante Montt street, (c) façade in Arturo Prat street, (d) staggered masonry walls (images by Salazar (2014), and e) main section of the *Hotel Reina Victoria* in Sotomayor square (by Salazar (2014)).

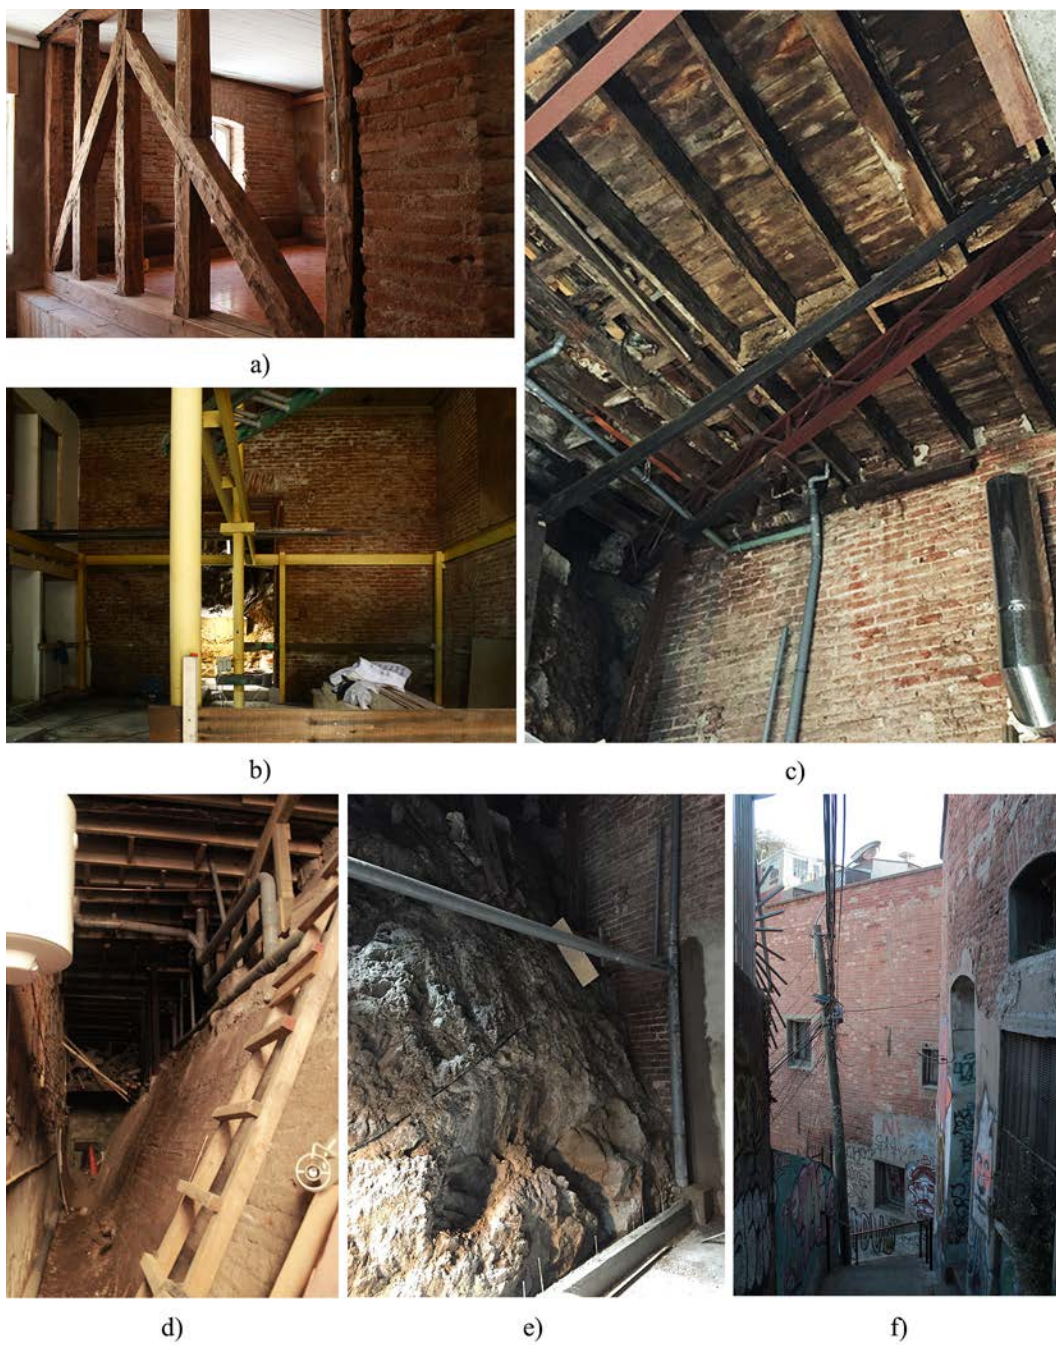
Internal load bearing walls typically consist of timber frame structures made of Oregon pine or Oakwood. Direct internal inspection is always a difficult activity, mainly because the walls are commonly covered by the plaster. Representative walls which presented good inspection conditions were evaluated in order to determine their typical configuration. The principal components of the timber frames are vertical elements, named studs or posts, spaced at $0.4 \div 0.6 \text{ m}$ from each other, and placed between horizontal elements called sills and plates. The posts are usually braced with diagonal elements, as shown

in Figure 12a. This wall configuration is replicated along the height of the buildings and in-between the stories, according to the configuration called *platform frame*. The cross-section of the timber frame elements varies between $0.125 \times 0.125 \text{ m}^2$ to $0.10 \times 0.10 \text{ m}^2$ depending on the function of the frame, e.g. internal or external load-bearing wall. Generally, oak elements presented better state of conservation in terms of decay damage and biotic attack (termites), while pine ones showed more exposure to these damages, particularly in poorly insulated structures.

Figure 12. Typical features of masonry buildings in Valparaíso: (a) timber frame internal partition in Urriola street, (b) steel reinforcing structure, (c) timber story with reinforcing steel truss in Almirante Montt street, (d) gravity wall, (e) rock hillside visible from the interior of a building, and (f) side wall.

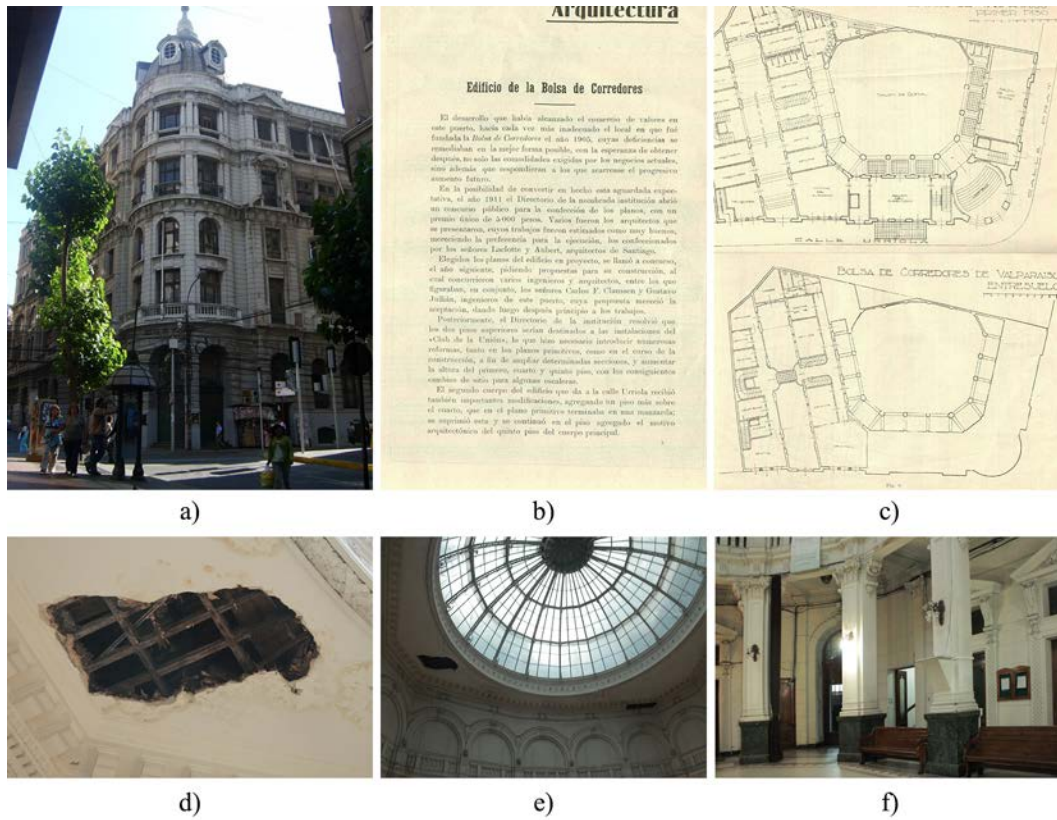
The *Bolsa de Valores de Valparaíso* was selected as case of study due to the excellent conditions of examination and the available technical reports which helped to make a consistent characterization of the hybrid structural typology. The structural and architectonic features of this buildings was widely described by Concreto Revista de Ingeniería y Arquitectura (1919) in Valparaíso. The construction of this Renaissance-style building, dating back to 1912 (Figure 14a), was undertaken by important engineer-architects of this period such as Carlos Claussen, Gustavo Jullian and the Italians Arnaldo Barison and Renato Schiavon. The building is located at the bottom of the Cerro Alegre at Urriola and Arturo Prat streets and it is positioned in the corner of the row in a semi-staggered land. The construction covers an area of 960 m² and 37.50 m up to the dome. The main load-bearing system is made of laminated “C” profiles and complex truss systems of wrought iron, filled with plain concrete. The dimension of the profiles varies with the height of the buildings at each story. First and second floors have the largest section profiles, i.e. “C” profiles of 0.25 m depth. The walls of the third and fourth floors have smaller “C” profiles with heights of 0.20 m and 0.15 m, respectively. The fifth story structure present double “T” profiles with 0.15 m height. Sidewalls present wrought iron double “T” posts of 0.2 m height spaced at 2.5 m and linked by at least two horizontal profiles. The thickness of the plain concrete fill of the frame is 0.25 m. The overall configuration of interior walls is similar to that of the main façade, with iron profiles filled with plain concrete and thicknesses varying from 0.20 m to 0.4 m. Isolated continuous

Figure 14. Typical mixed iron-reinforced concrete building (*Bolsa de Valores de Valparaíso*): (a) façade, (b-c) technical report and plan of the ground level, (d-e) roof and dome damages and (f) interior columns

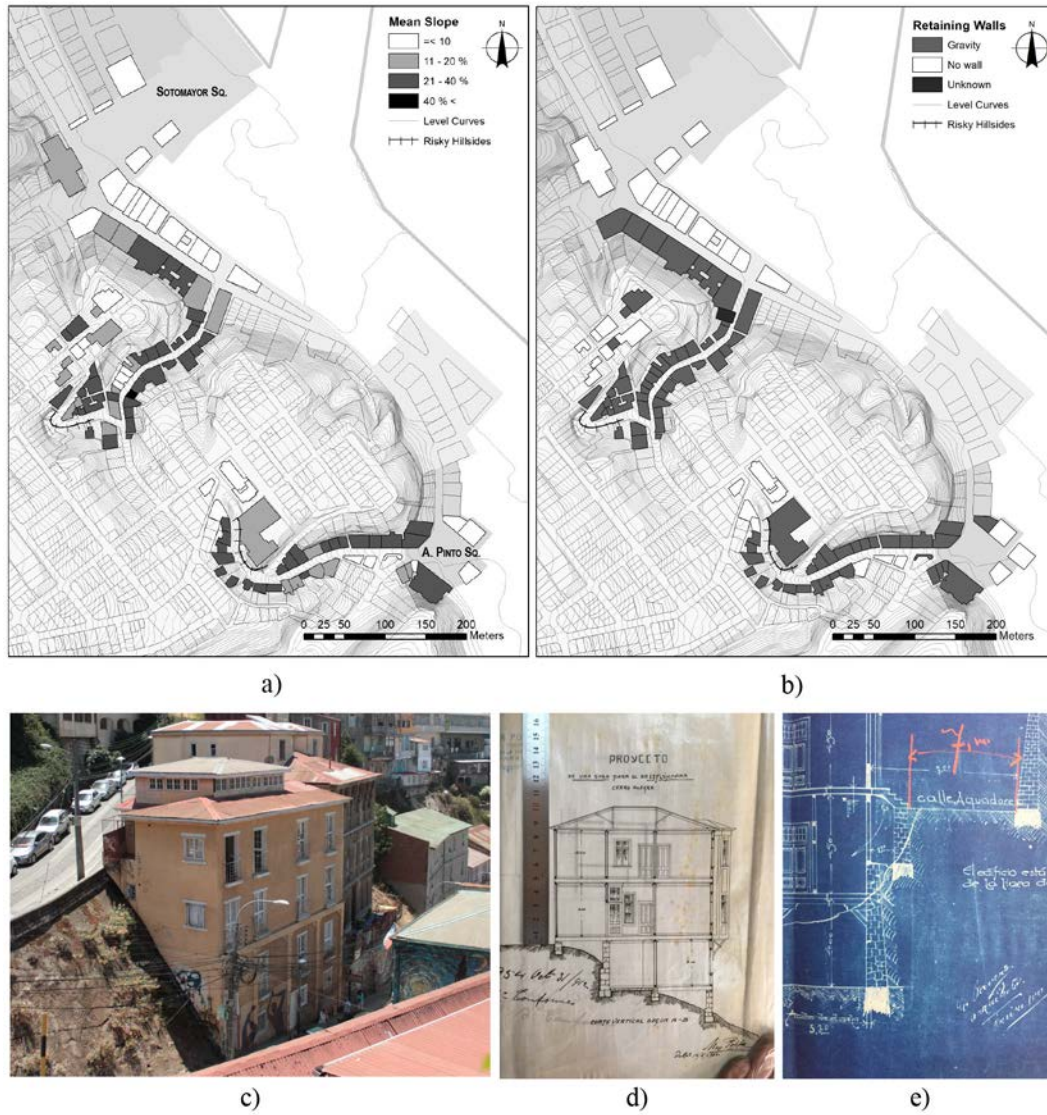
A large number of masonry buildings are located on Almirante Montt street, where the terrain is very steep ($20 \div 40\%$ slope). In these cases, the use of gravity retaining walls is recurrent to contain the surrounding thrusting soil. The thickness of a retaining wall is normally variable, and commonly vary between 2.0 m at the foundation to 0.5 m at the top. In some specific cases, these walls receive loads from the upper walls and story structures, as shown in Figure 12d. It should be noted that gravity walls are not present in hard rock soil zones, such as in the Almirante Montt and Urriola streets, as shown in Figure 12e. Gravity walls presented many difficulties of inspection due to their hidden condition. However, the representative gravity walls investigated in the hills prove to be made of materials of suitable quality and derived from a good seismic design, given their satisfactory seismic performance during past-earthquakes. The typical foundation system is the brick or stone masonry strip footing. Raised buildings, commonly placed in significantly steep lots, make use of a platform made of quarry stone. These buildings sometimes present habitable basements built with stone or brick masonry gravity walls. Staggered buildings in steep terrains present commonly difference of levels in the foundations ($1 \div 2 \text{ m}$ average), a condition that negatively influences the seismic response of a structure according to GNDT (2007).

Figure 22. Slope and retaining walls configuration: a) GIS mapping of mean slope and (b) retaining wall typologies, (c) representative case in Almirante Montt street, (d-e) typical retaining walls and foundations.

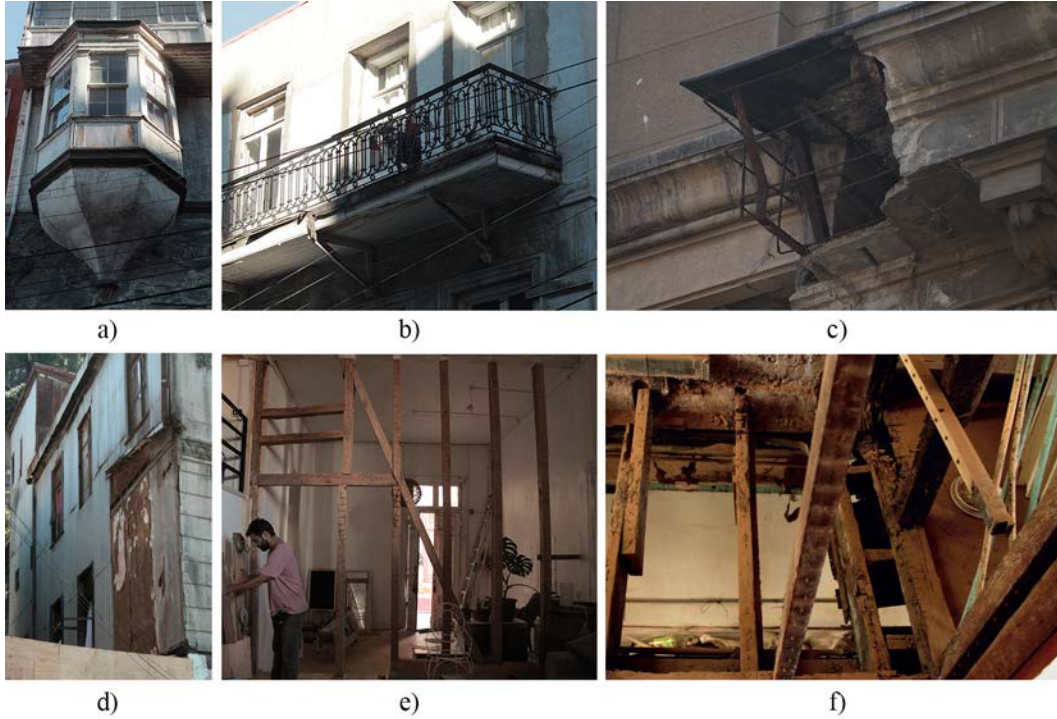
Buildings with large bow-windows, projecting stairs, gutters, ornaments or badly connected sheathing represent conditions of concern in case of earthquake. Non-structural elements do not present important damage conditions and were considered as null or slight in most of the cases.

The damage recognition on the internal elements is always a challenging activity, thus external factors such as moisture detection and termites' residues on the surfaces are good indicators to identify damage conditions on structural elements. The degradation of the material by biotic attacks, decay, and mechanical damage, generates large concern in timber structures. Termite attacks are the main source of deterioration in Valparaíso, especially in elements made of pine. Medium to severe damage in structural elements can highly decrease their mechanical resistances and consequently jeopardize the global behavior of the structure. A poor insulation of the structures interacting with the foundations and hillsides leads to accelerated decay of the wood due to the high moisture conditions. Depending on the level of damage, timber structures can be repaired by replacing the deteriorated pieces and this fact eases the maintenance of this type of buildings. Mechanical damages caused by major earthquakes or fires, such as partial detachment of portions of walls or structural elements, are the worst damage scenarios for these typologies.

Figure 23. Representative non-structural elements and damage conditions: (a) large dimension bow-window, (b) poorly connected balcony, (c) severe damage of RC cornice, (d) sheathing detachment, (e) empty timber frame wall and (f) timber joists attacked by termites.
